Total E & P Nigeria contacted Locker in August 2008 regarding a problem with the AMT2 flare deck. The Original Flare Deck had no Heatshield protection and the supporting steelwork was damaged by the elevated temperatures present. Numerous interim modifications were employed in an attempt to strengthen the structure but Locker Flare Deck protection was agreed as the best solution.

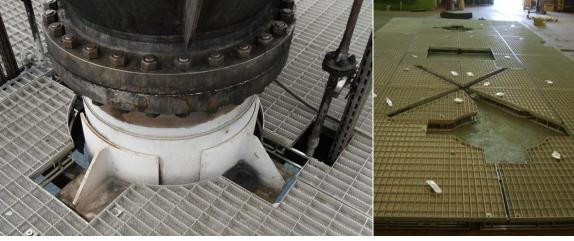
The replacement flare deck provided unique challenges in that the panels had to be shaped around the existing structure, and modifications undertaken over the years meant incorporation of a number of complex shapes. The above image shows the replacement flare deck undergoing trial fitting prior to despatch to the customer and highlights the complex challenge involved. These panels were designed, fabricated and delivered to a tight budget and delivery schedule, and subsequently installed within the specified period. Successful fulfilment of complex requirements strengthened our relationship with Total E&P in the West African region and further demonstrated our ability to meet any challenge asked of us.
